CERTIFIED SEPTIC INSPECTION

OUR FILE #SSISCOTTPOINTDRIVE365

**RE: Performance Inspection of the Onsite Sewerage System at
365 Scott Point Drive, Salt Spring Island, B.C.**

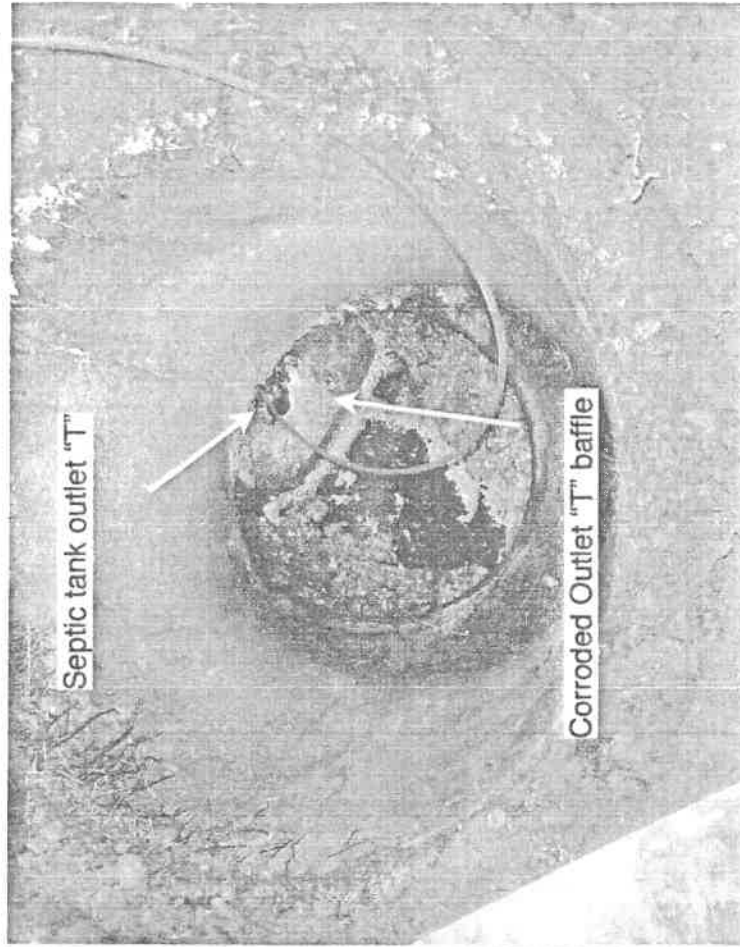
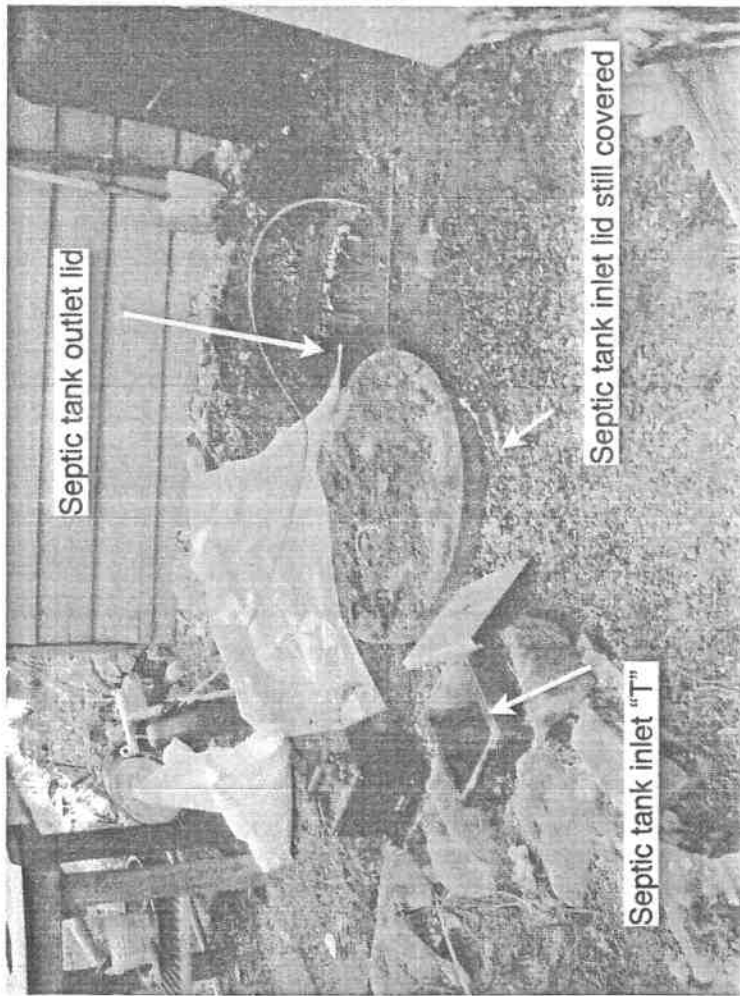
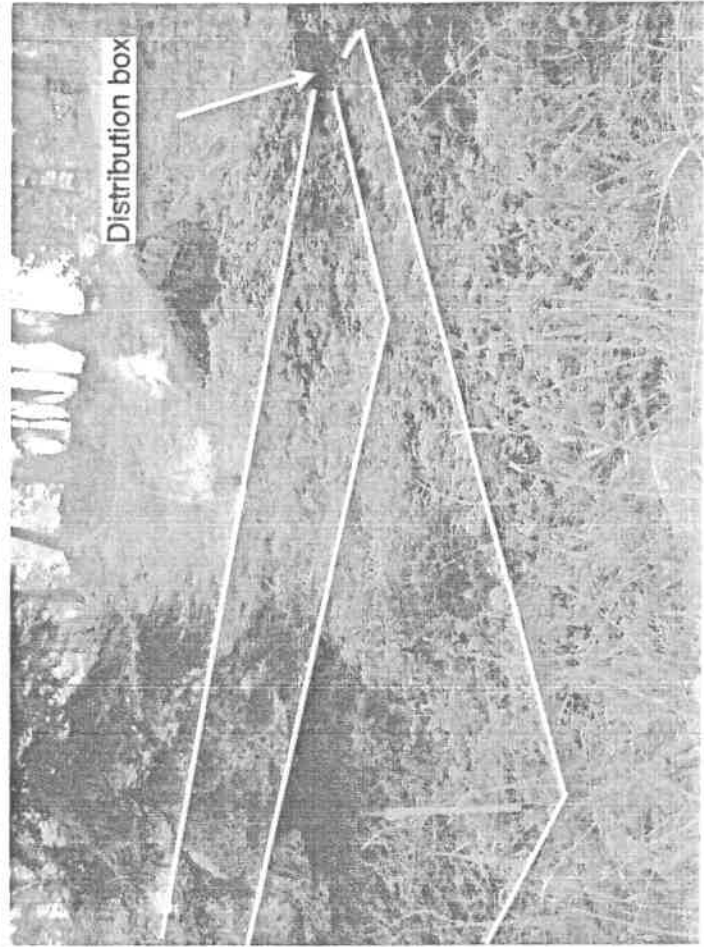
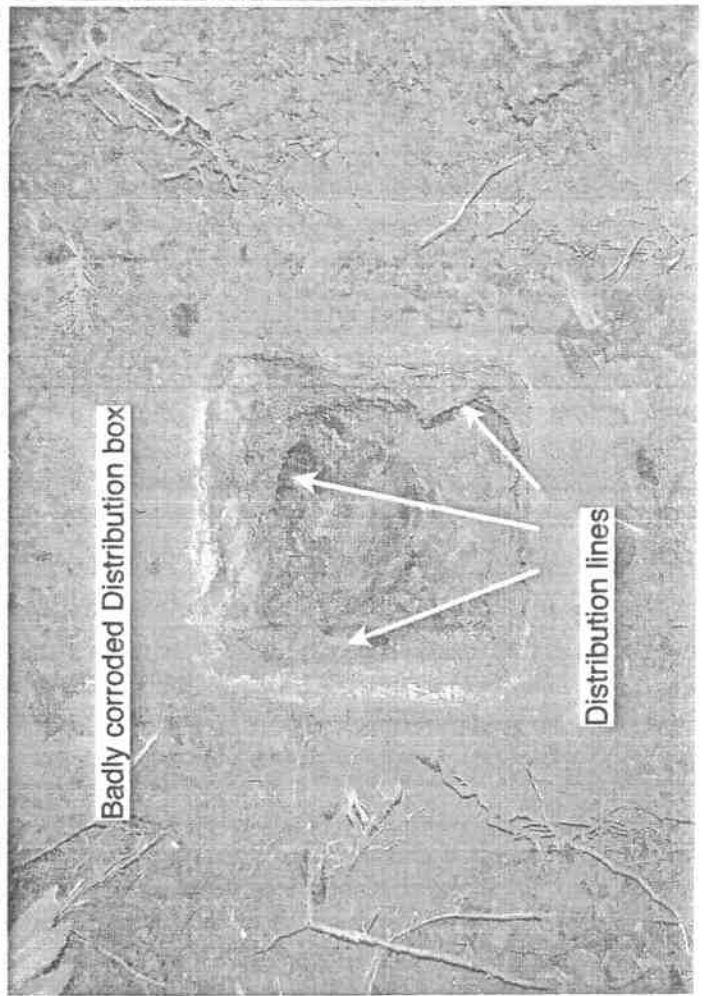
Please see attached photographs in regards to the system.

- Septic tank is a 600 gallon, two compartment precast concrete tank.
- Septic tank outlet lid was removed to inspect the interior of the tank.
- The liquid layer in the tank is 44 inches deep and the scum layer is 4 inches. Septic tank does not need to be pumped out at this time.
- The septic tank outlet "T" baffle is in poor condition. The top and sides of the tank are in good condition.
- Distribution box was located approximately 50 feet from the septic tank. It is approximately 12 inches below ground level.
- Distribution box lid was exposed and removed. The "D" box is in poor condition.
- Pipe camera was sent down the three distribution lines, they were found to be clear with very little bio-mass.
- Upper 2 lines are 40 feet in length and lower line is 25 feet in length, for a total of 105 feet of distribution line.
- Septic field is working properly.

- Corroded distribution box needs to be replaced.
- A septic system Installer should be contacted for their services.
- Septic tank should be pumped out every 3-5 years or as needed.
